INSPECTION REPORT

For the Property at:
40 HILLSIDE DRIVE
TORONTO, ON M4K 2M2

Prepared for: ROGER TRAVASSOS and MEL KELLY
Inspection Date: Friday, January 19, 2024
Prepared by: Tim Palmer

RE: Report No. 2711, v.3
40 Hillside Drive
Toronto, ON
M4K 2M2

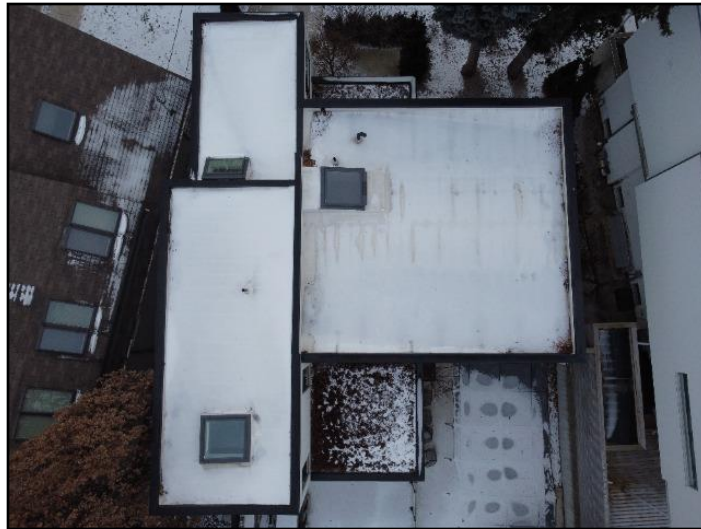
1. Condition: • Due to excess snow and ice coverage on roof, we recommend a full roof inspection when roof is clear by a qualified roofer.

1. Snow/ice/frost

Task: Further evaluation by a certified Contractor

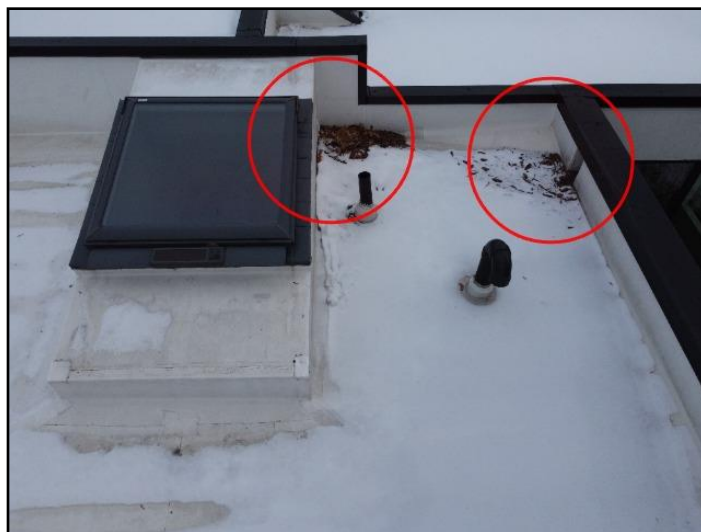
2. Condition: • Debris/oil on roof

Implication(s): Chance of water damage to structure, finishes and contents

2. Debris/oil on roof

Task: Clean

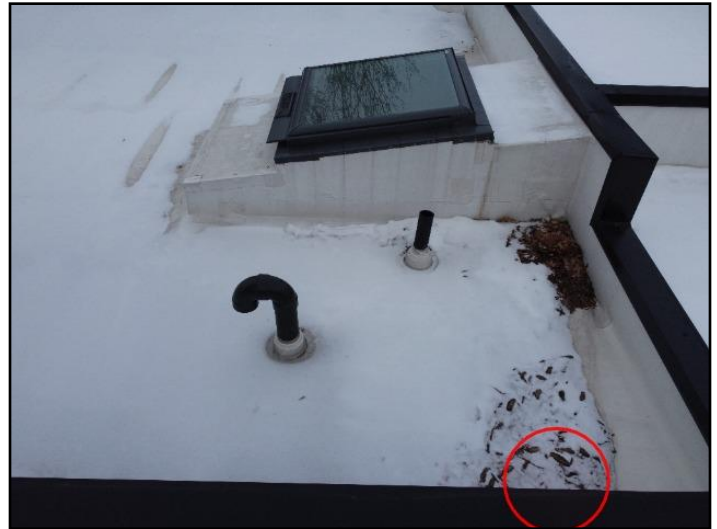
3. Condition: • Clogged

Roof gardens and debris can block drainage

4. Clogged

Task: Clean

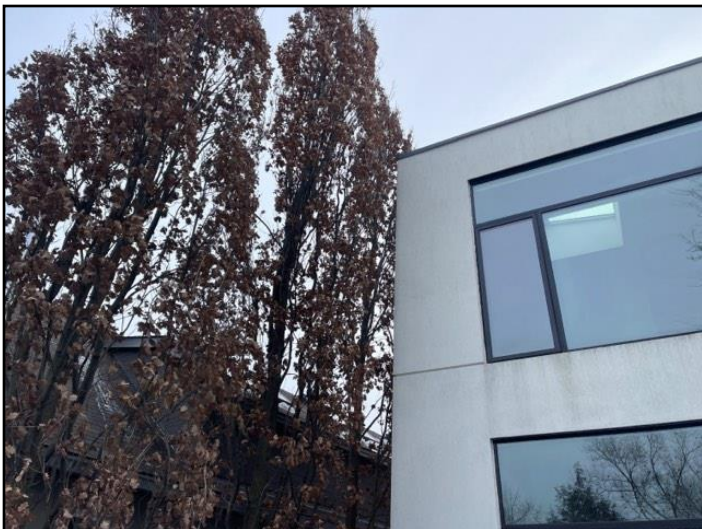
4. Condition: • Trees or shrubs too close to building

Implication(s): Chance of water damage to structure, finishes and contents | Chance of pests entering building | Material deterioration

5. Trees or shrubs too close to building

Task: Remove or trim back

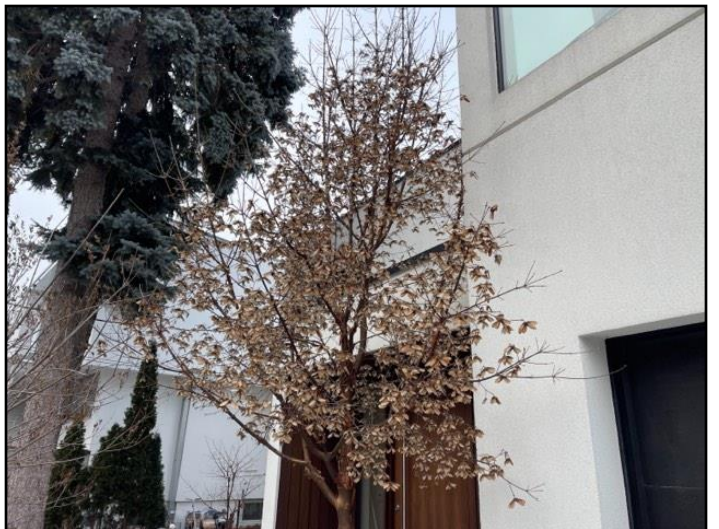
6. Trees or shrubs too close to building

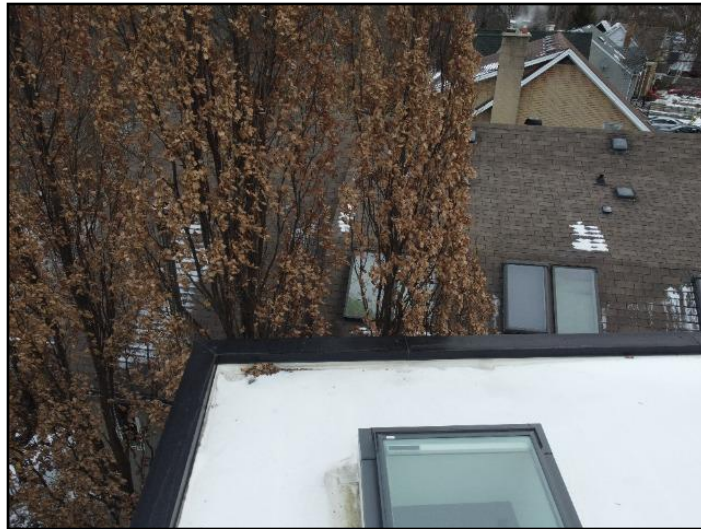
7. Trees or shrubs too close to building

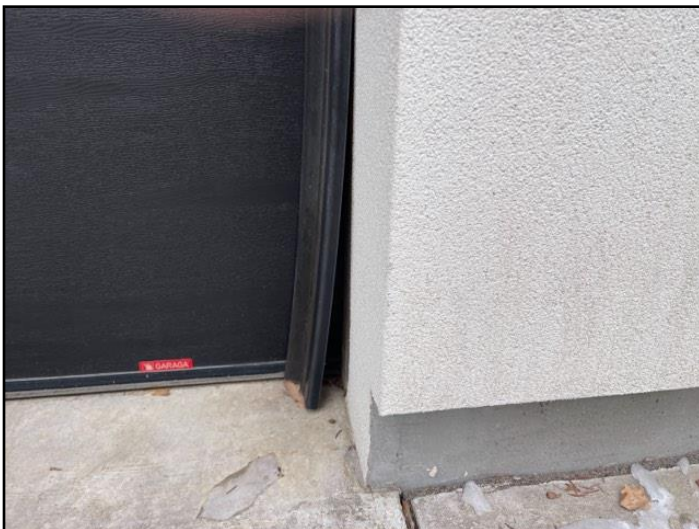
5. Condition: • Weatherstripping damaged or missing.

Loose

8. Weatherstripping damaged or missing.

Task: Repair

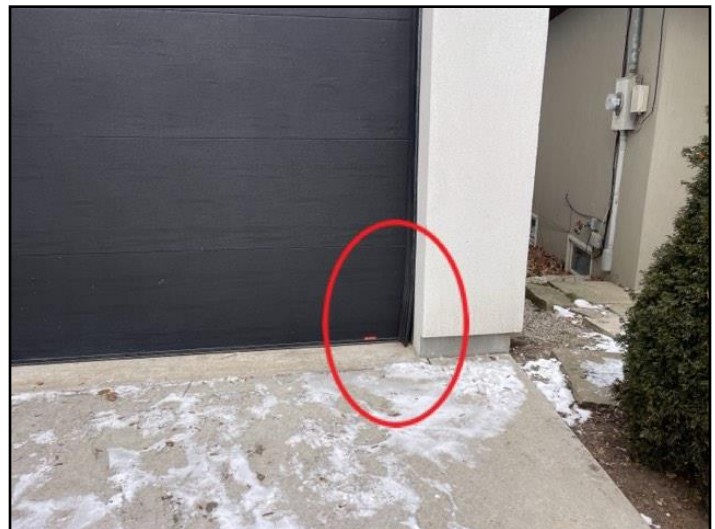
9. Weatherstripping damaged or missing.

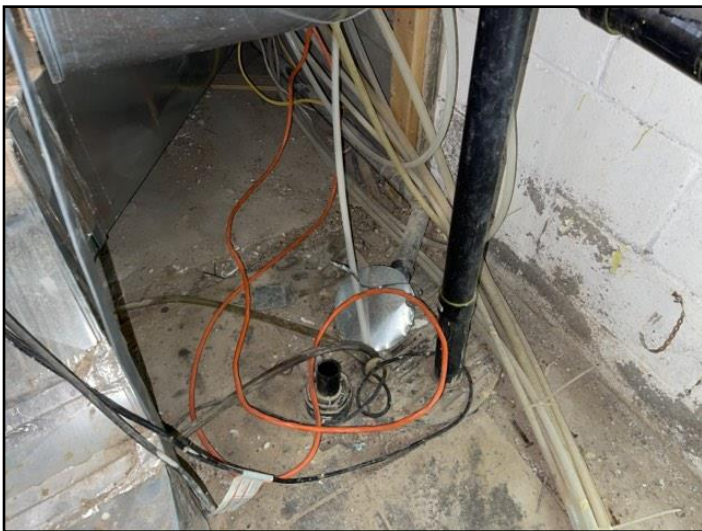
8. Condition: • Not well secured

Implication(s): Fire hazard | Electric shock

Location: Basement Utility Room

10. Not well secured

Task: Improve

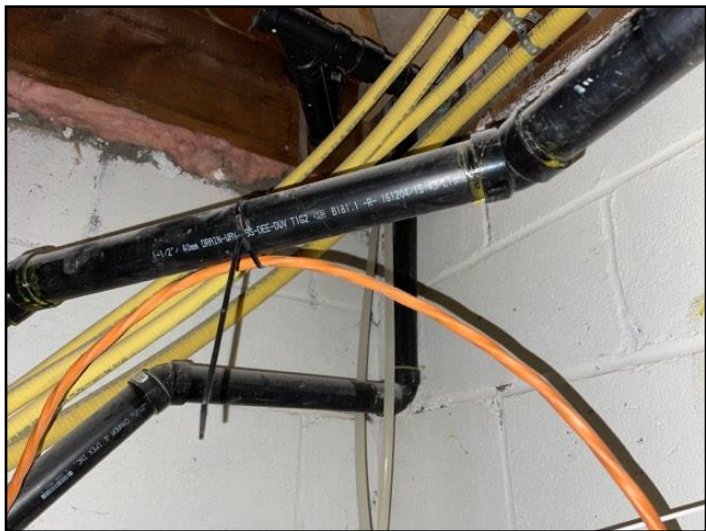
11. Not well secured

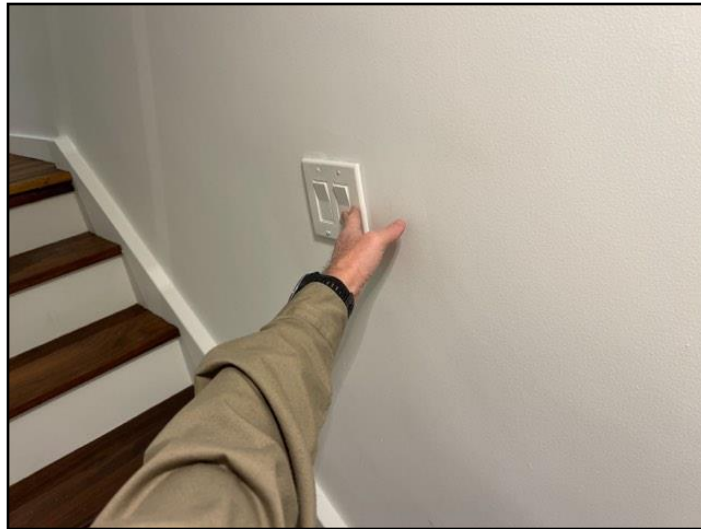
- 9. Condition:** • Inoperative
- Implication(s):** Inadequate lighting
- Location:** Basement. Bottom of stairs
- Task:** Further evaluation
- Time:** Discretionary

12. Inoperative

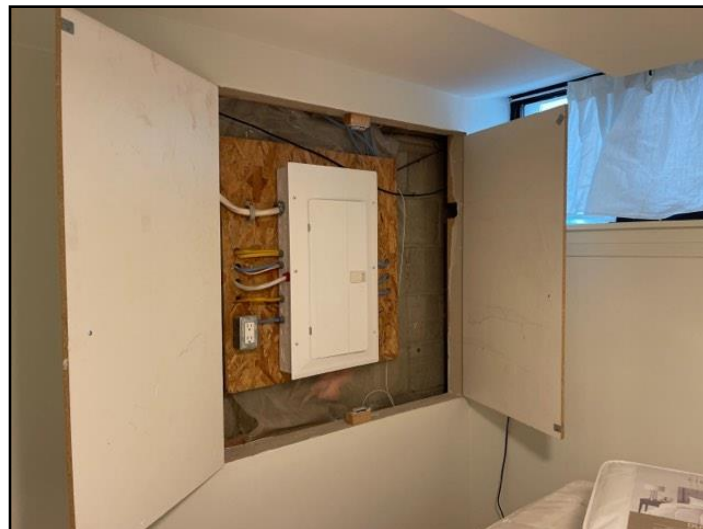
10. Condition: • Missing

Also requires Vapor barrier

Implication(s): Increased heating costs

Location: Basement around sub panel

24. Missing

Task: Provide

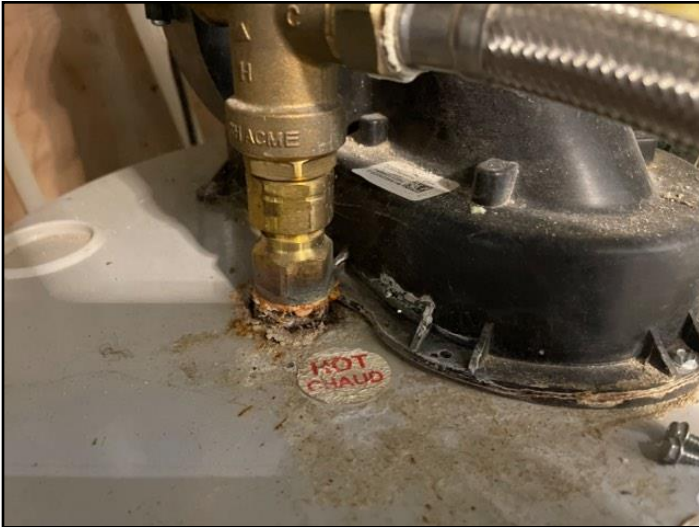
11. Condition: • Rust
Implication(s): Leakage
Location: Main unit
Task: Service
Time: As soon as possible

25. Rust

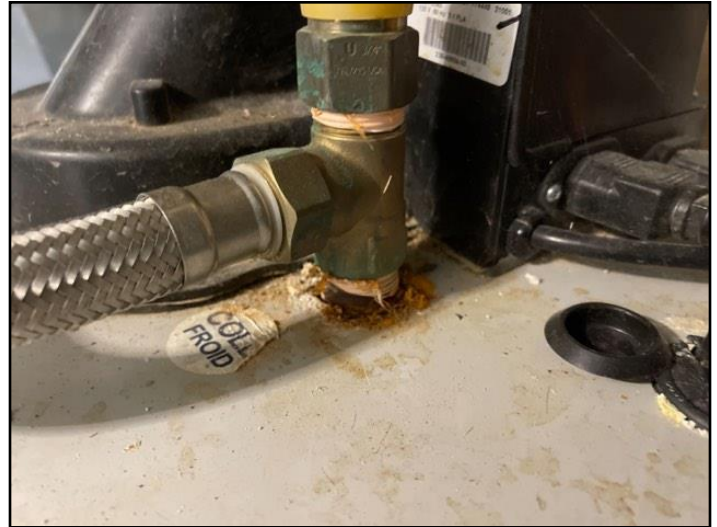
26. Rust

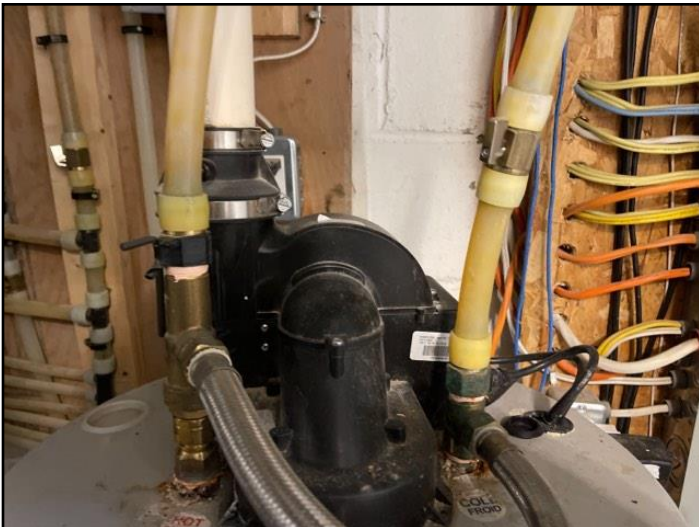
12. Condition: • PEX connected direct to water heater.
Task: Further evaluation by a certified Contractor
Time: As soon as possible

27. PEX connected direct to water heater.

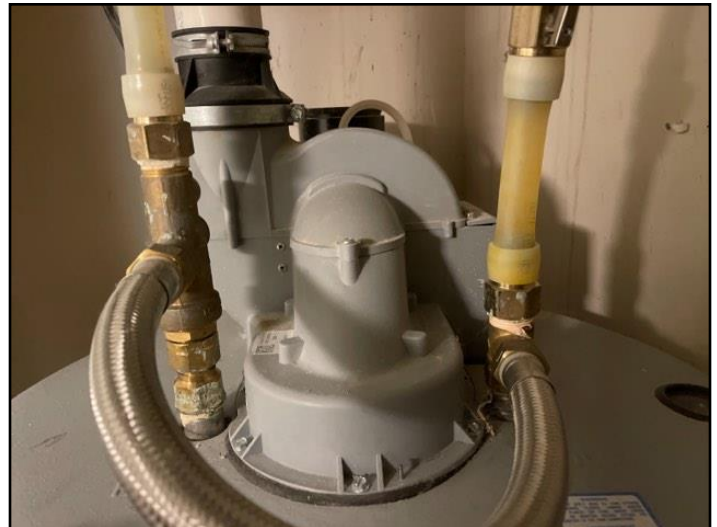
28. PEX connected direct to water heater.

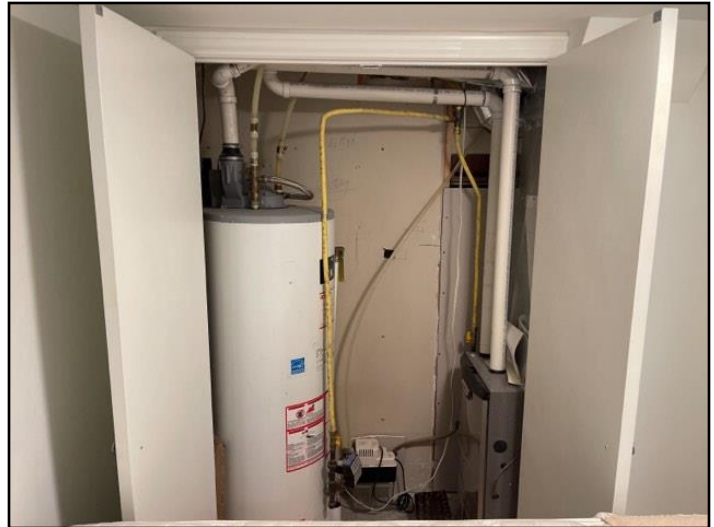
13. Condition: • Poor - Closet

Implication(s): Hazardous combustion products entering home

30. Poor - Closet

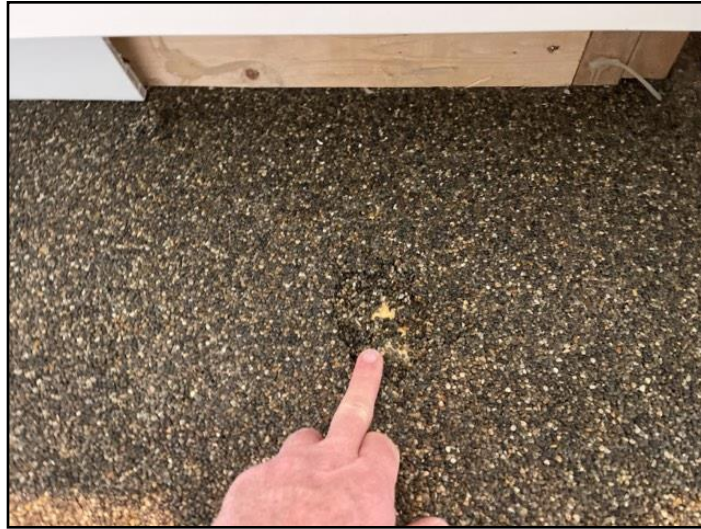
14. Condition: • Damage
Implication(s): Trip hazard
Location: First Floor Laundry Area
Task: Repair
Time: As soon as practical

38. Damage

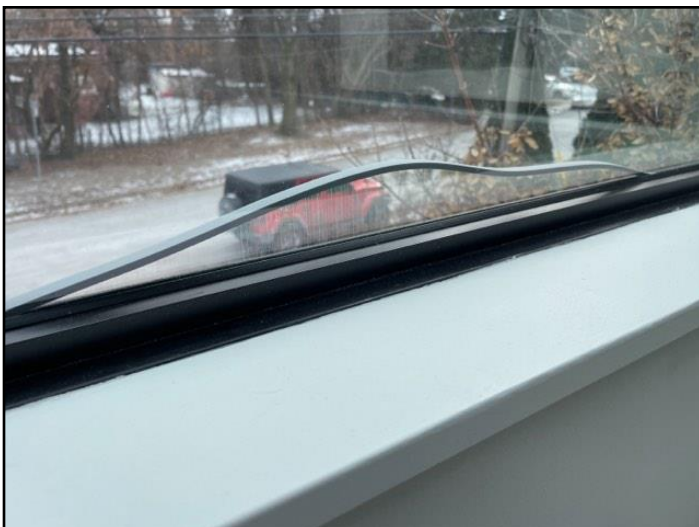
39.

15. Condition: • Lost seal on double or triple glazing
Implication(s): Shortened life expectancy of material
Location: Various Second Floor
Task: Replace
Time: When necessary

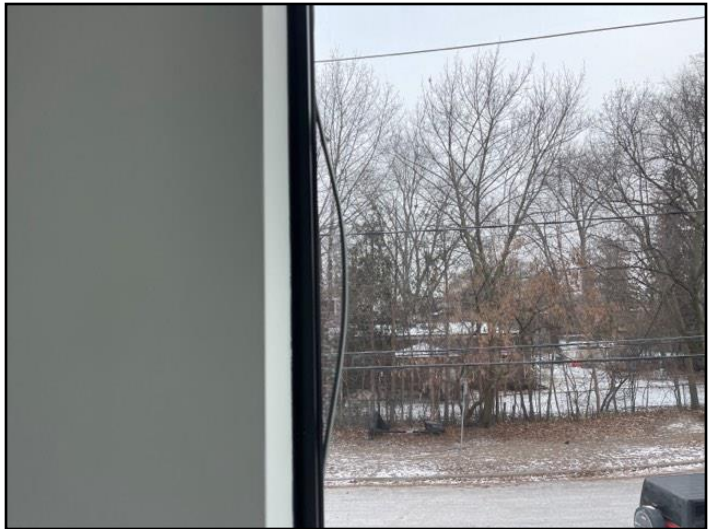
42. Lost seal on double or triple glazing

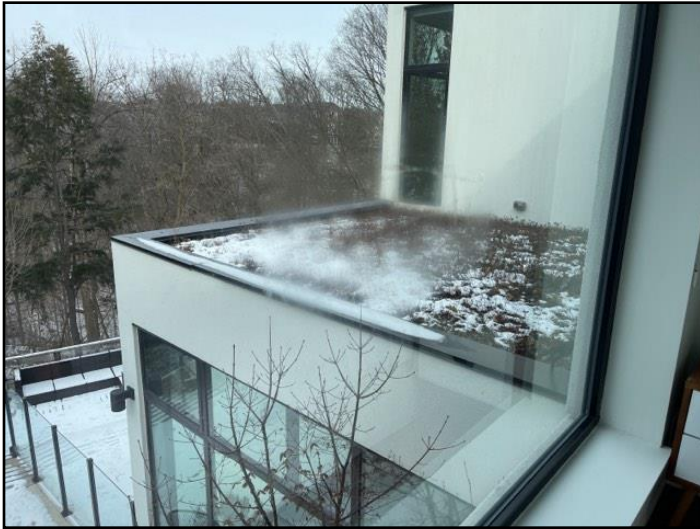
43.

16. Condition: • Lost seal on double or triple glazing
Implication(s): Shortened life expectancy of material
Location: Rear Second Floor
Task: Replace
Time: When necessary

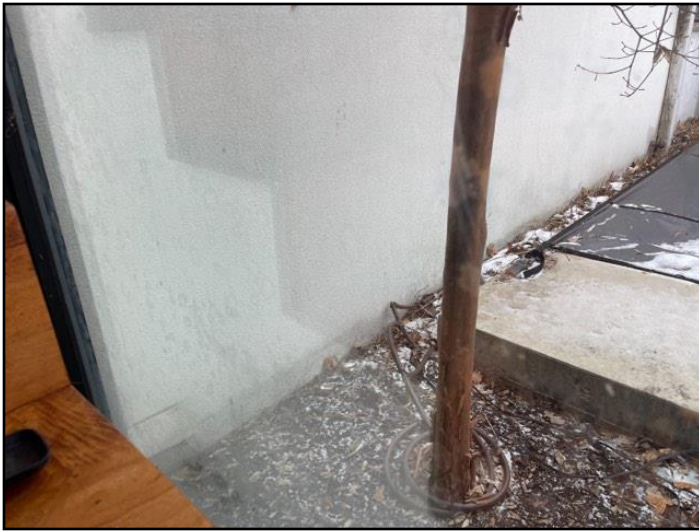
17. Condition: • Lost seal on double or triple glazing

49. Lost seal on double or triple glazing

Task: Replace

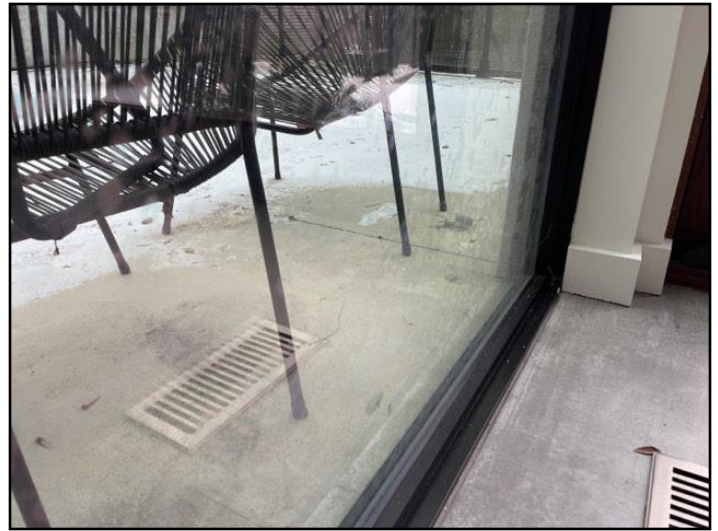
50. Lost seal on double or triple glazing

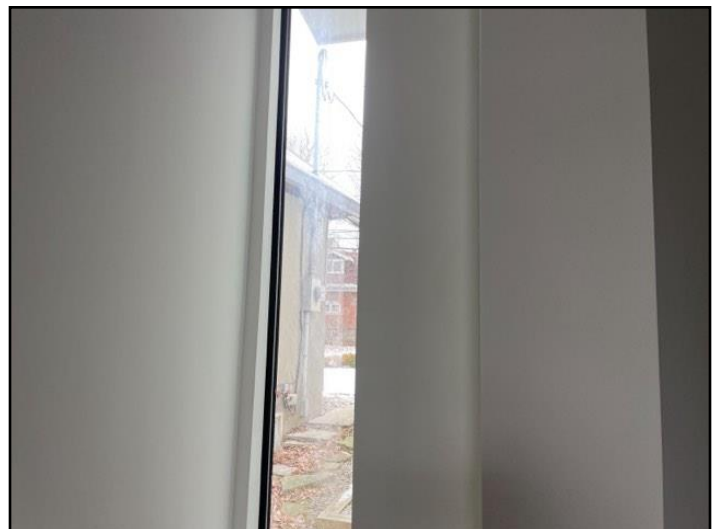
52. Lost seal on double or triple glazing

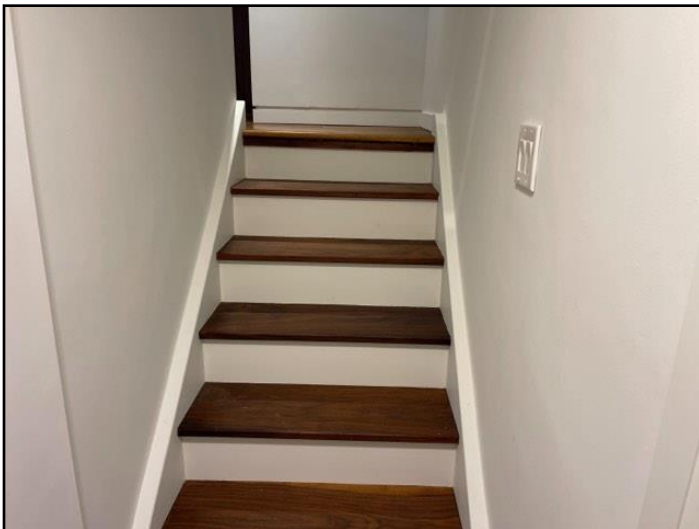
18. Condition: • Missing

Implication(s): Fall hazard

53. Missing

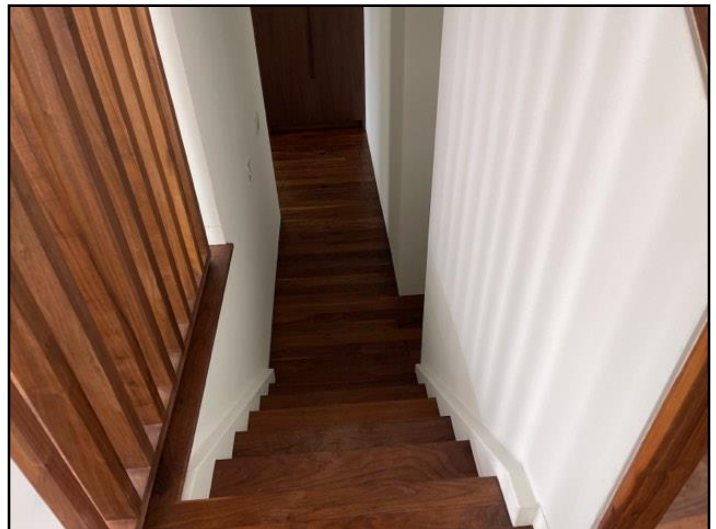
54. Missing

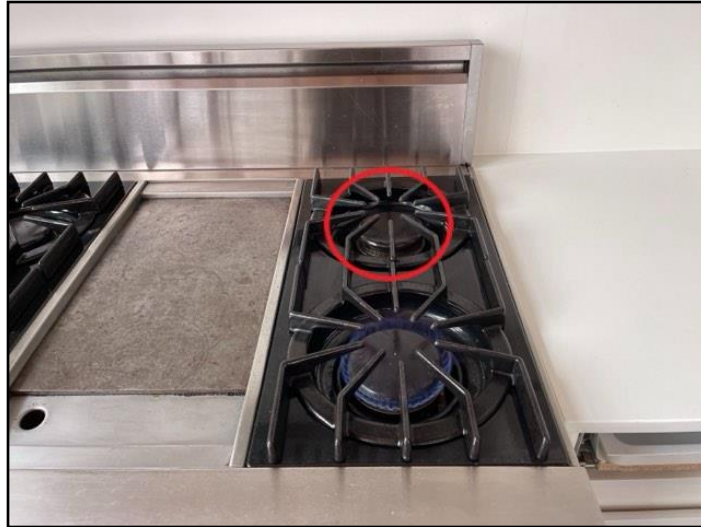
55.

19. Condition: • Pilot inoperative
Implication(s): System inoperative

Task: Service

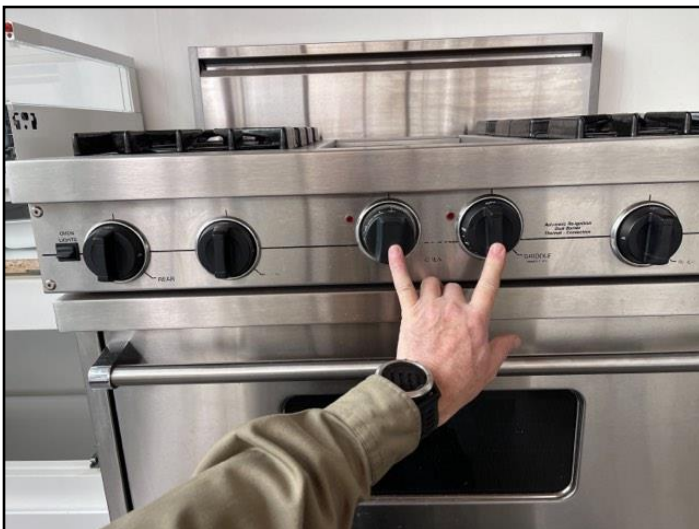
Condition: • Knobs broken

Gas may not shut off when not in use

20. Condition: • Knobs broken

56. Knobs broken

Task: Service

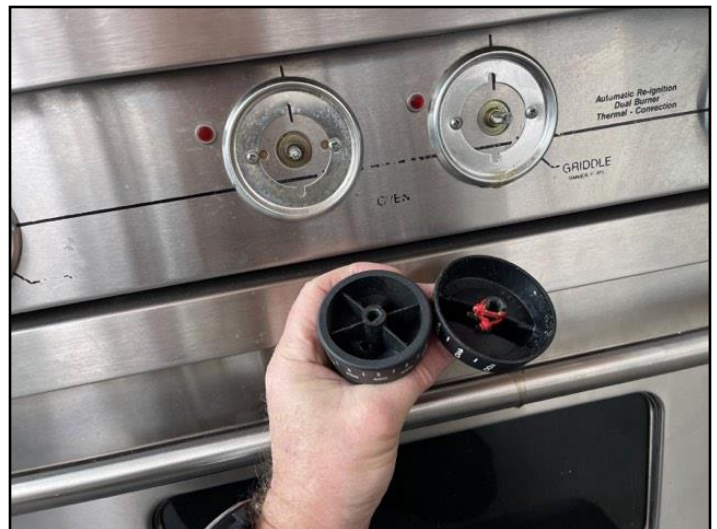
57. Knobs broken
