INSPECTION REPORT

For the Property at:
40 HILLSIDE DRIVE
TORONTO, ON M4K 2M2

Prepared for: ROGER TRAVASSOS and MEL KELLY
Inspection Date: Friday, January 19, 2024
Prepared by: Tim Palmer

RE: Report No. 2711, v.3
40 Hillside Drive
Toronto, ON
M4K 2M2

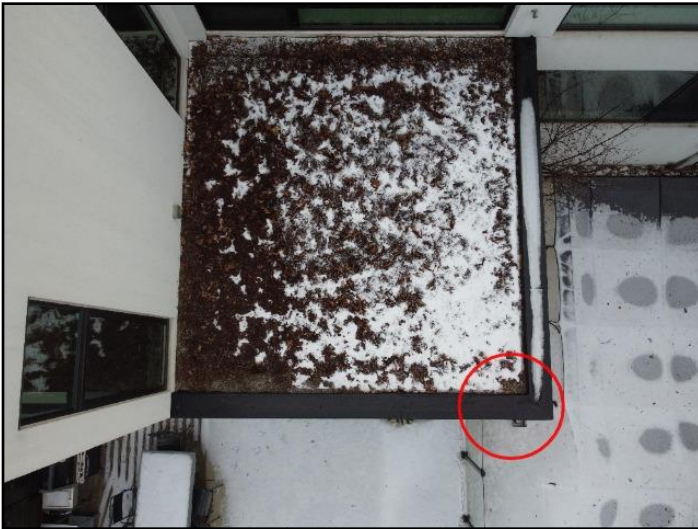
3. Clogged

3. Condition: • Clogged

Implication(s): Chance of water damage to structure, finishes and contents

Task: Clean

Time: As soon as practical & annually

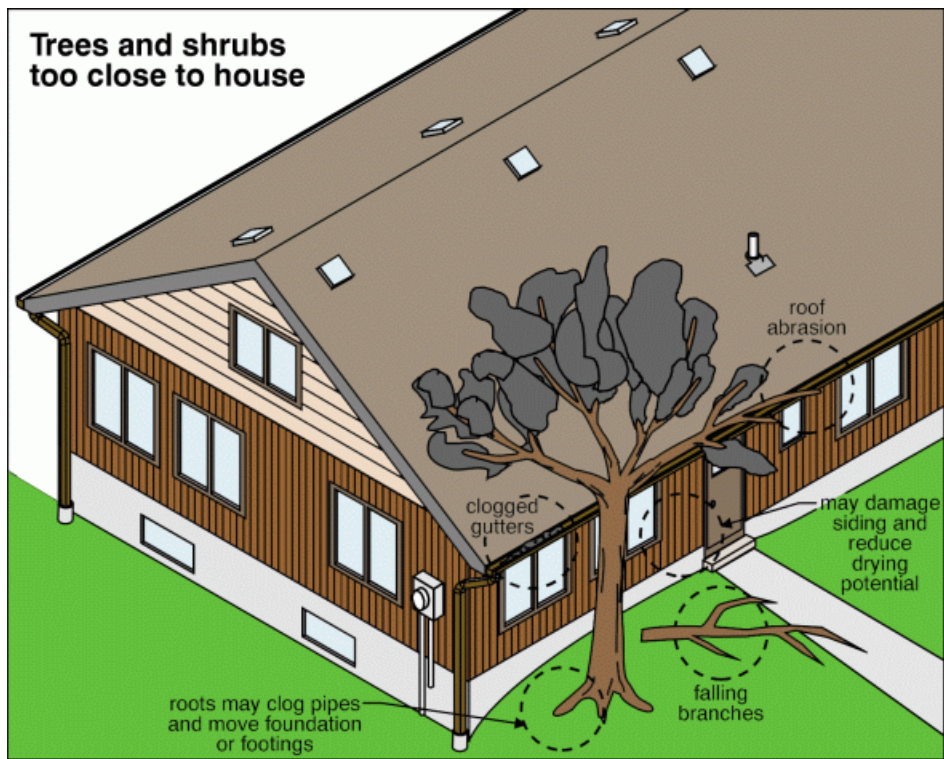
5. Trees or shrubs too close to building

4. Condition: • Trees or shrubs too close to building

Implication(s): Chance of water damage to structure, finishes and contents | Chance of pests entering building | Material deterioration

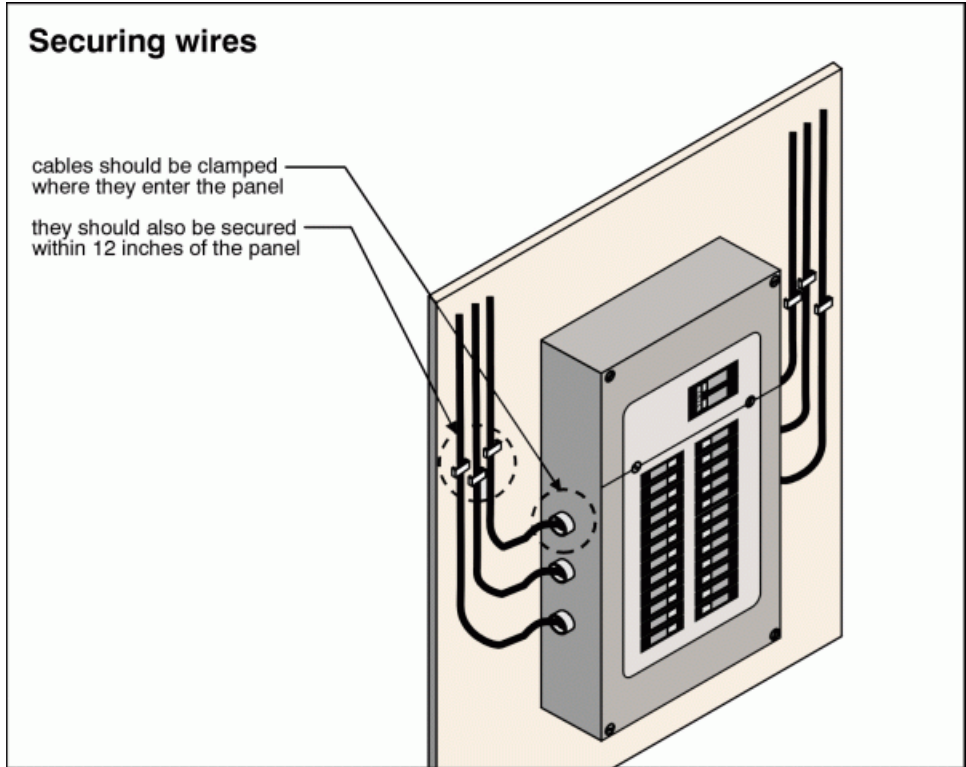
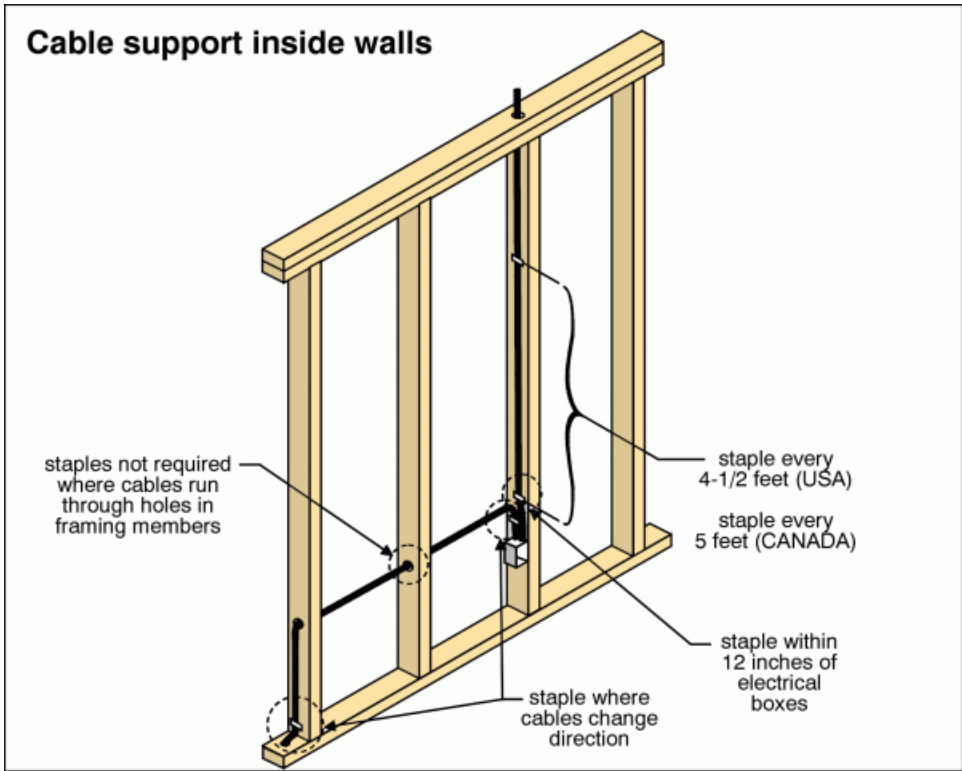
10. Not well secured

8. Condition: • Not well secured

Implication(s): Fire hazard | Electric shock

Task: Improve

Time: As soon as possible

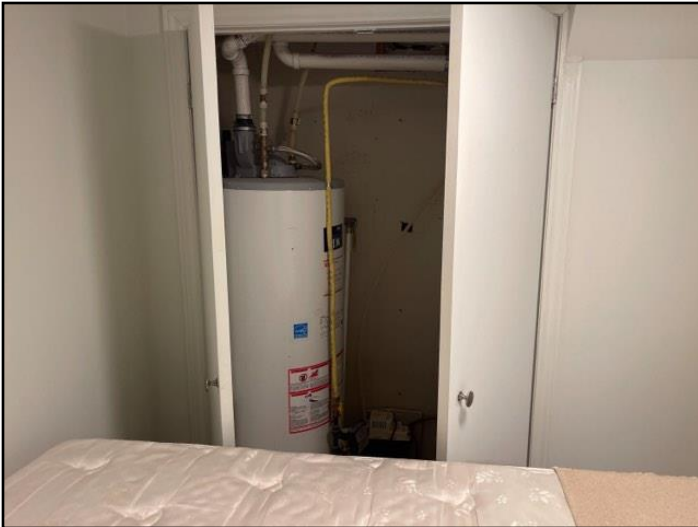
29. Poor - Closet

13. Condition: • Poor - Closet

Implication(s): Hazardous combustion products entering home

Task: Further evaluation by a certified Contractor

Time: Immediate

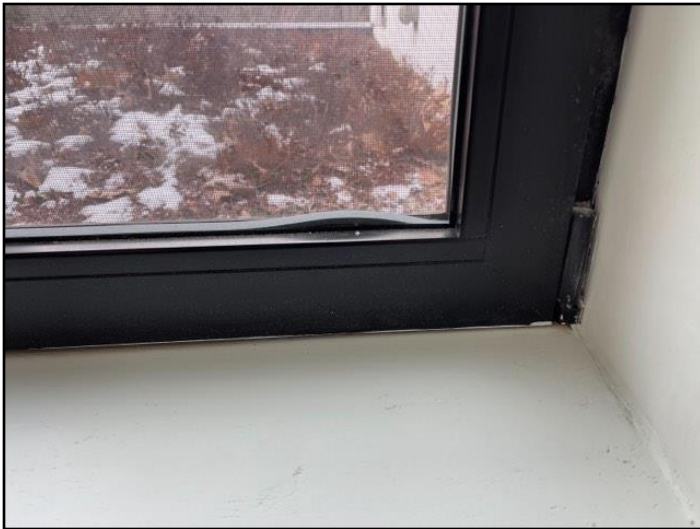
41.

15. Condition: • Lost seal on double or triple glazing
Implication(s): Shortened life expectancy of material
Location: Various Second Floor
Task: Replace
Time: When necessary

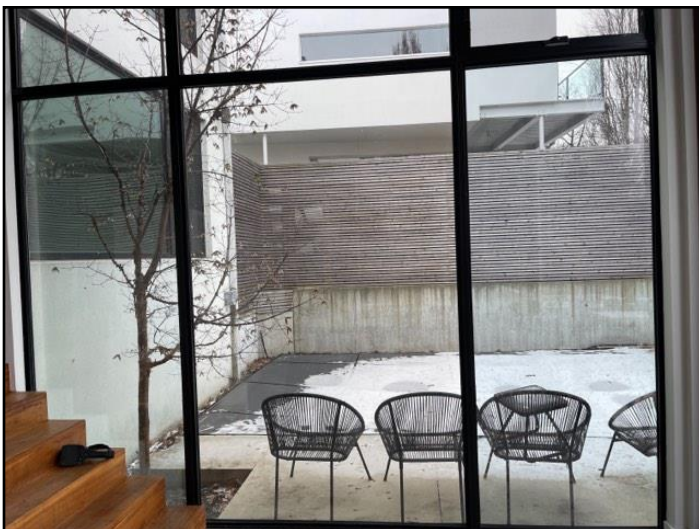
51. Lost seal on double or triple glazing

17. Condition: • Lost seal on double or triple glazing

Task: Replace

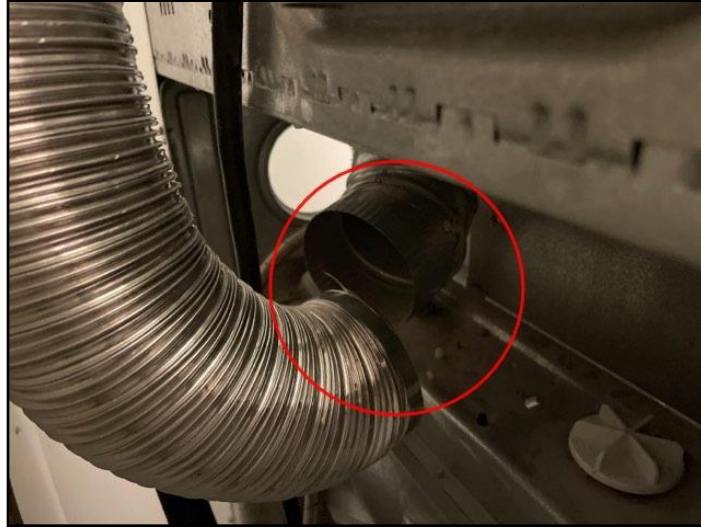
58. Dryer vent disconnected

21. Condition: • Dryer vent disconnected

Implication(s): Chance of damage to finishes and structure | Equipment not operating properly | Fire hazard | Odors, molds, etc.

Task: Correct

Time: Immediate
